Alur Ilmu

Perihal

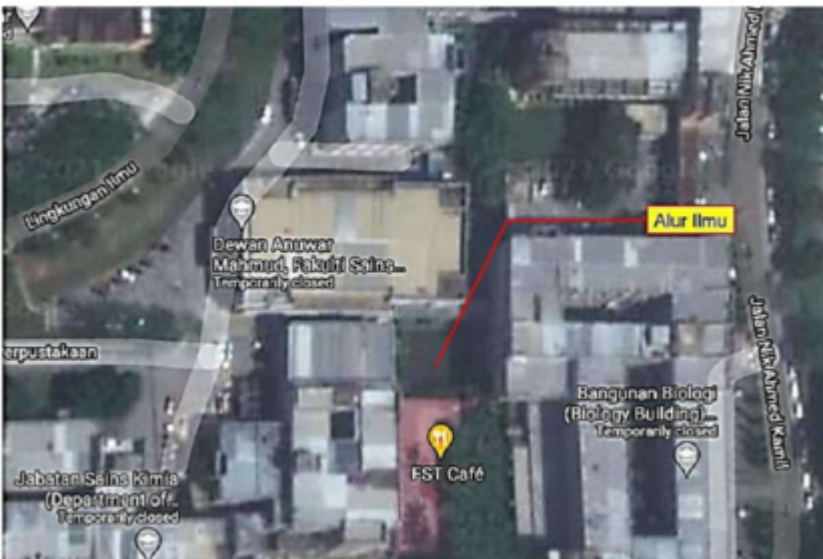
RAJAH	LOKASI / ARAS	KOMPONEN	KECACATAN / KEROSAKAN	KETERANGAN
Kanan	Aras Bawah dan "tunnel"	Dinding, siling dan lantai	Kulat kelembapan	Hampir keseluruhan kawasan (dinding, siling dan lantai) di kawasan "tunnel" dan ruang berhampirannya berkulat teruk. "Tunnel" sentiasa menakung air kotor daripada pelbagai sumber seperti banjir, kebocoran paip dan sebagainya. Melalui temubual, wakil UKM memaklumkan bahawa, sistem saliran air sedia ada masuk ke dalam bangunan, manakala pam yang ada tidak berfungsi. Paras air yang bertakung dalam bangunan mencecah sehingga ke paras lutut. Selain itu, air juga masuk dari pelbagai sumber seperti hujan, "tunnel", tasik dan lain-lain. Apabila aliran alur air yang dikenali sebagai "alur ilmu" (tasik berhampiran bangunan kimia) melimpah, airnya dikatakan pernah memasuki ke ruang bawah bangunan. Air juga keluar daripada tepi (kiri kanan tanah). Kulat yang terjadi di kawasan "tunnel" mungkin merupakan salah satu punca utama bermulanya perebakan kulat di bangunan ini.

Laporan forensik JKR pada Ogos 2021 mengenalpasti antara faktor utama masalah kulat yang dikesan pada beberapa bangunan di UKM ialah aliran Alur Ilmu di situ.
