Alur Ilmu

2012-2018: Kajian Pencemaran

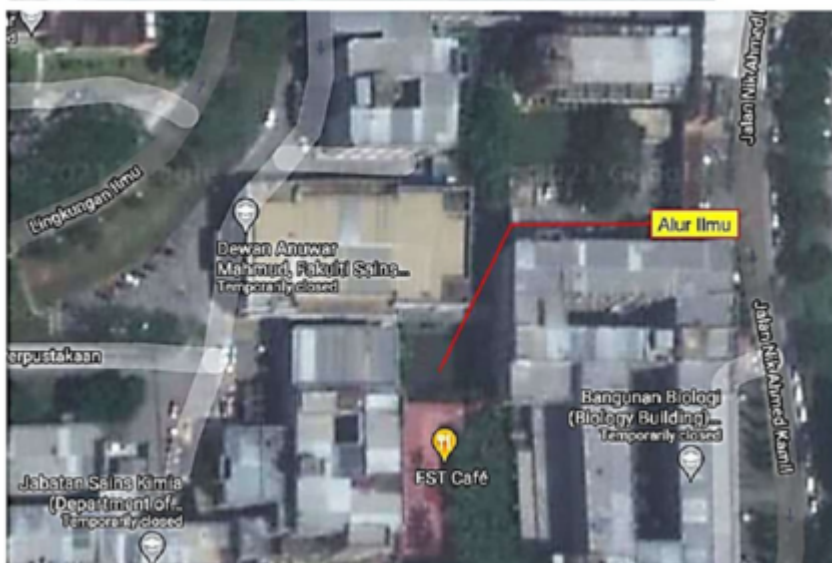
RAJAH	LOKASI / ARAS	KOMPONEN	KECACATAN / KEROSAKAN	KETERANGAN
Kanan	Aras Bawah dan "tunnel"	Dinding, siling dan lantai	Kulat kelembapan	Hampir keseluruhan kawasan (dinding, siling dan lantai) di kawasan "tunnel" dan ruang berhampirannya berkulat teruk. "Tunnel" sentiasa menakung air kotor daripada pelbagai sumber seperti banjir, kebocoran paip dan sebagainya. Melalui temubual, wakil UKM memaklumkan bahawa, sistem saliran air sedia ada masuk ke dalam bangunan, manakala pam yang ada tidak berfungsi. Paras air yang bertakung dalam bangunan mencecah sehingga ke paras lutut. Selain itu, air juga masuk dari pelbagai sumber seperti hujan, "tunnel", tasik dan lain-lain. Apabila aliran alur air yang dikenali sebagai "alur ilmu" (tasik berhampiran bangunan kimia) melimpah, airnya dikatakan pernah memasuki ke ruang bawah bangunan. Air juga keluar daripada tepi (kiri kanan tanah). Kulat yang terjadi di kawasan "tunnel" mungkin merupakan salah satu punca utama bermulanya perebakan kulat di bangunan ini.

Laporan forensik JKR pada Ogos 2021 mengenalpasti antara faktor utama masalah kulat yang dikesan pada beberapa bangunan di UKM ialah aliran Alur Ilmu di situ.
