Alur Ilmu

2012-2018: Kajian Pencemaran

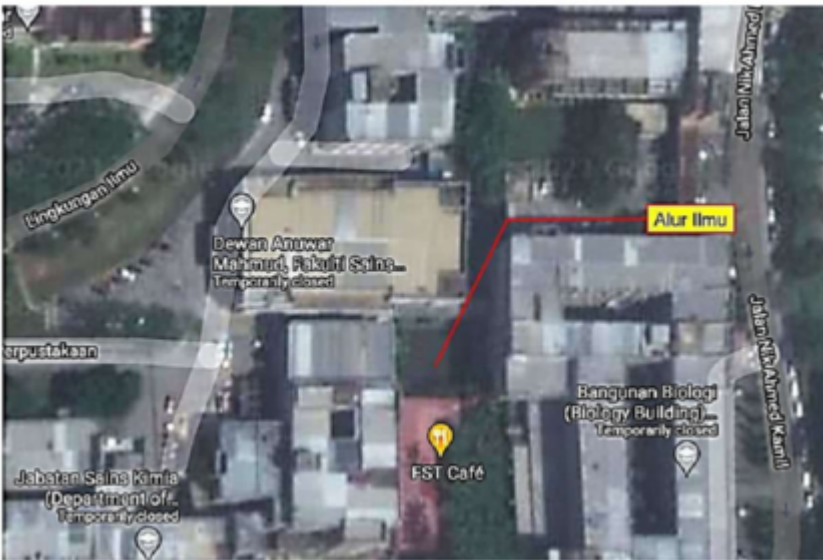
RAJAH	LOKASI / ARAS	KOMPONEN	KECACATAN / KEROSAKAN	KETERANGAN
Kanan	Aras Bawah dan "tunnel"	Dinding, siling dan lantai	Kulat kelembapan	<p>Hampir keseluruhan kawasan (dinding, siling dan lantai) di kawasan "tunnel" dan ruang berhampirannya berkulat teruk. "Tunnel" sentiasa menakung air kotor daripada pelbagai sumber seperti banjir, kebocoran paip dan sebagainya. Melalui temubual, wakil UKM memaklumkan bahawa, sistem saliran air sedia ada masuk ke dalam bangunan, manakala pam yang ada tidak berfungsi. Paras air yang bertakung dalam bangunan mencecah sehingga ke paras lutut. Selain itu, air juga masuk dari pelbagai sumber seperti hujan, "tunnel", tasik dan lain-lain. Apabila aliran air yang dikenali sebagai "alur ilmu" (tasik berhampiran bangunan kimia) melimpah, airnya dikatakan pernah memasuki ke ruang bawah bangunan. Air juga keluar daripada tepi (kiri kanan tanah). Kulat yang terjadi di kawasan "tunnel" mungkin merupakan salah satu punca utama bermulanya perebakan kulat di bangunan ini.</p>

Laporan forensik JKR pada Ogos 2021 mengenalpasti antara faktor utama masalah kulat yang dikesan pada beberapa bangunan di UKM ialah aliran Alur Ilmu di situ.
