# Alur Ilmu

## Perihal

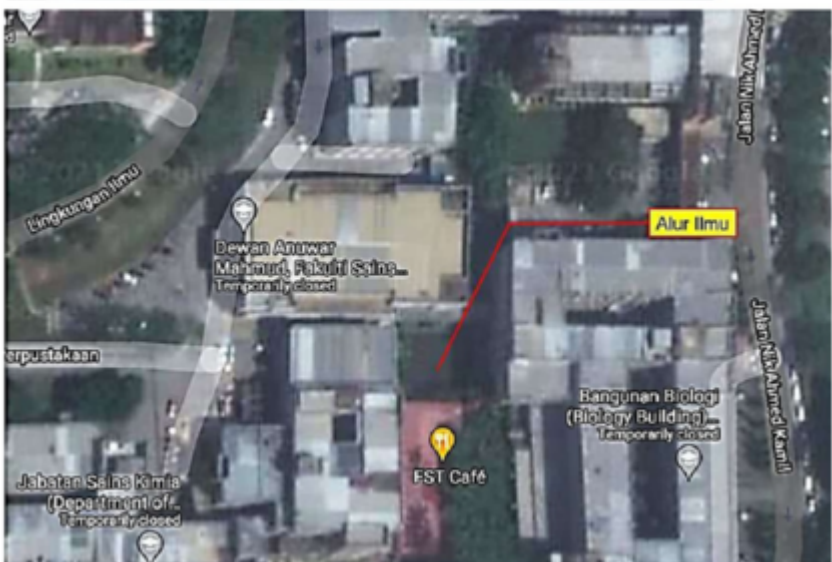
RAJAH	LOKASI / ARAS	KOMPONEN	KECACATAN / KEROSAKAN	KETERANGAN
Kanan	Aras Bawah dan "tunnel"	Dinding, siling dan lantai	Kulat kelembapan	Hampir keseluruhan kawasan (dinding, siling dan lantai) di kawasan "tunnel" dan ruang berhampirannya berkulat teruk. "Tunnel" sentiasa menakung air kotor daripada pelbagai sumber seperti banjir, kebocoran paip dan sebagainya. Melalui temubual, wakil UKM memaklumkan bahawa, sistem saliran air sedia ada masuk ke dalam bangunan, manakala pam yang ada tidak berfungsi. Paras air yang bertakung dalam bangunan mencecah sehingga ke paras lutut. Selain itu, air juga masuk dari pelbagai sumber seperti hujan, "tunnel", tasik dan lain-lain. Apabila aliran air yang dikenali sebagai "alur ilmu" (tasik berhampiran bangunan kimia) melimpah, airnya dikatakan pernah memasuki ke ruang bawah bangunan. Air juga keluar daripada tepi (kiri kanan tanah). Kulat yang terjadi di kawasan "tunnel" mungkin merupakan salah satu punca utama bermulanya perebakan kulat di bangunan ini.

Laporan forensik JKR pada Ogos 2021 mengenalpasti antara faktor utama masalah kulat yang dikesan pada beberapa bangunan di UKM ialah aliran Alur Ilmu di situ.
